HOUSATONIC RIVER BASIN
SHERMAN, CONNECTICUT

LAKE MAUWEEHOO DAM
CT 00321

PHASE I INSPECTION REPORT
NATIONAL DAM INSPECTION PROGRAM

June, 1981

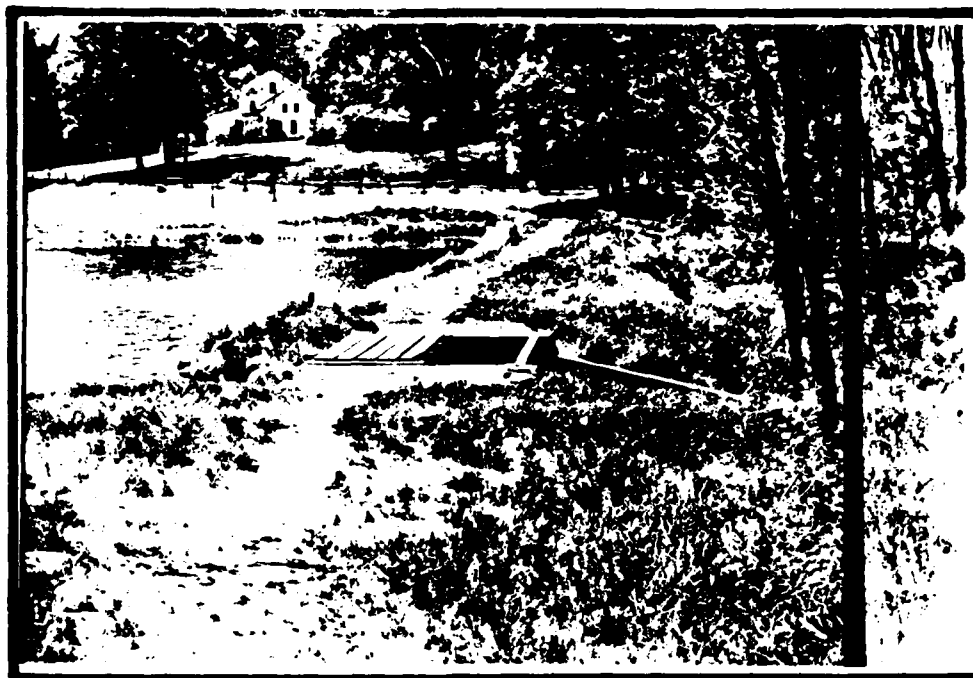
CREST OF DAM

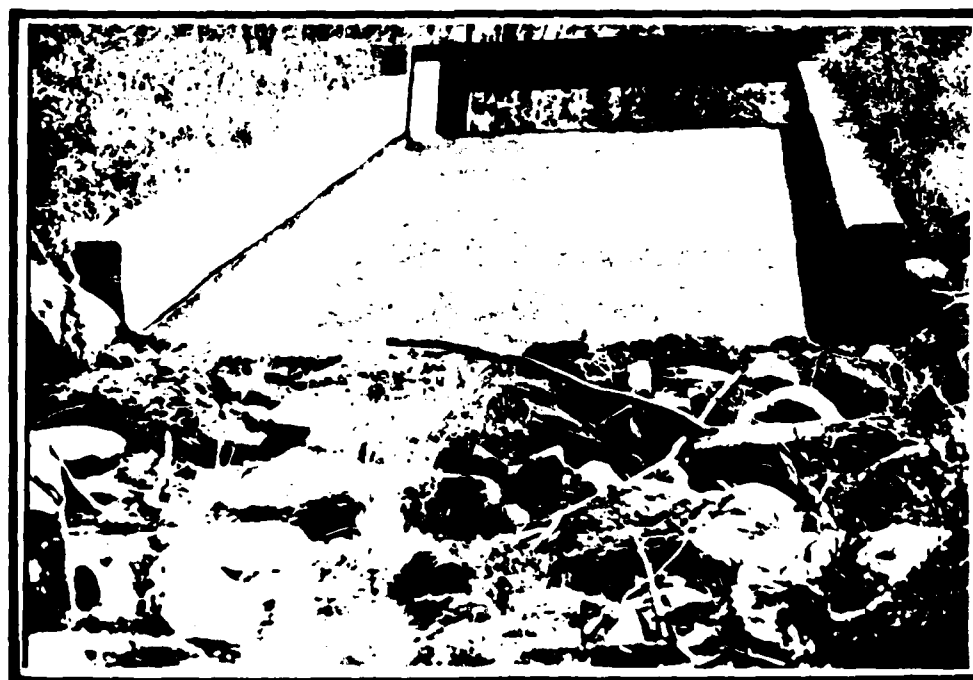
PRINCIPAL SPILLWAY
